6.3 ARCHITECTURAL COMPONENTS

6.3.1 EXTERIOR WALL COMPONENTS

6.3.1.5 GLASS BLOCK

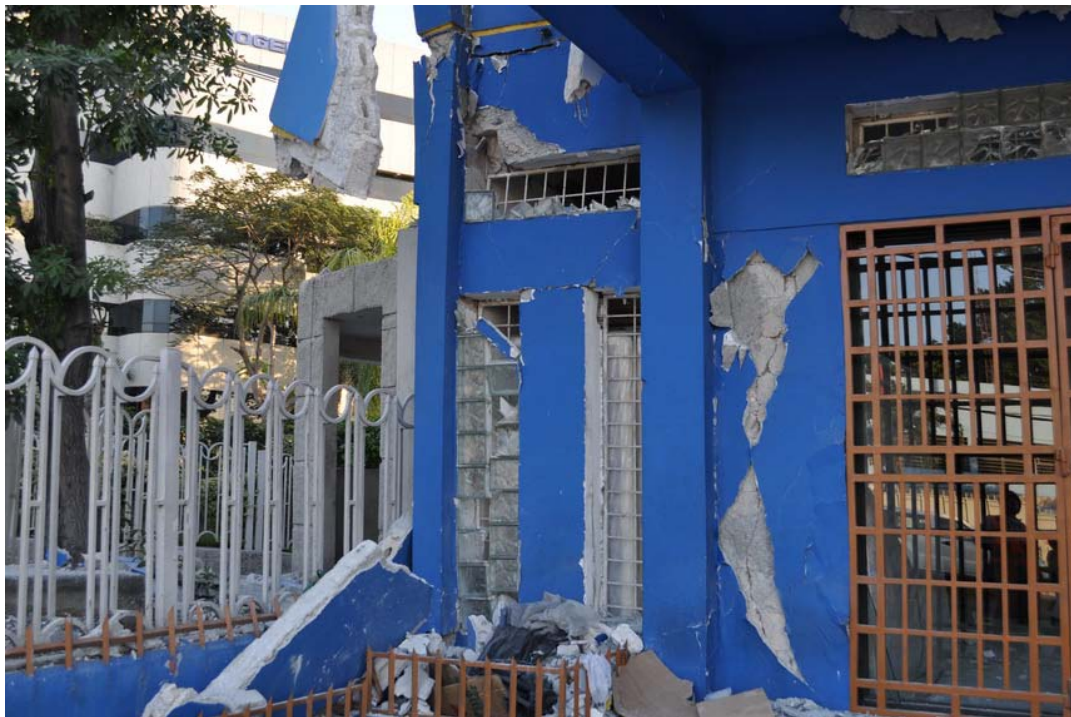
Figure 6.3.1.5-1 Damage to glass block in building with reinforced concrete frame and concrete masonry infill in the magnitude-7 2010 Haiti Earthquake (Photo courtesy of Eduardo Fierro, BFP Engineers). Note some blocks failed at rigid mortar joints and stayed in the frame, others fell out of the frame, and others broke in place. This building also suffered structural damage.

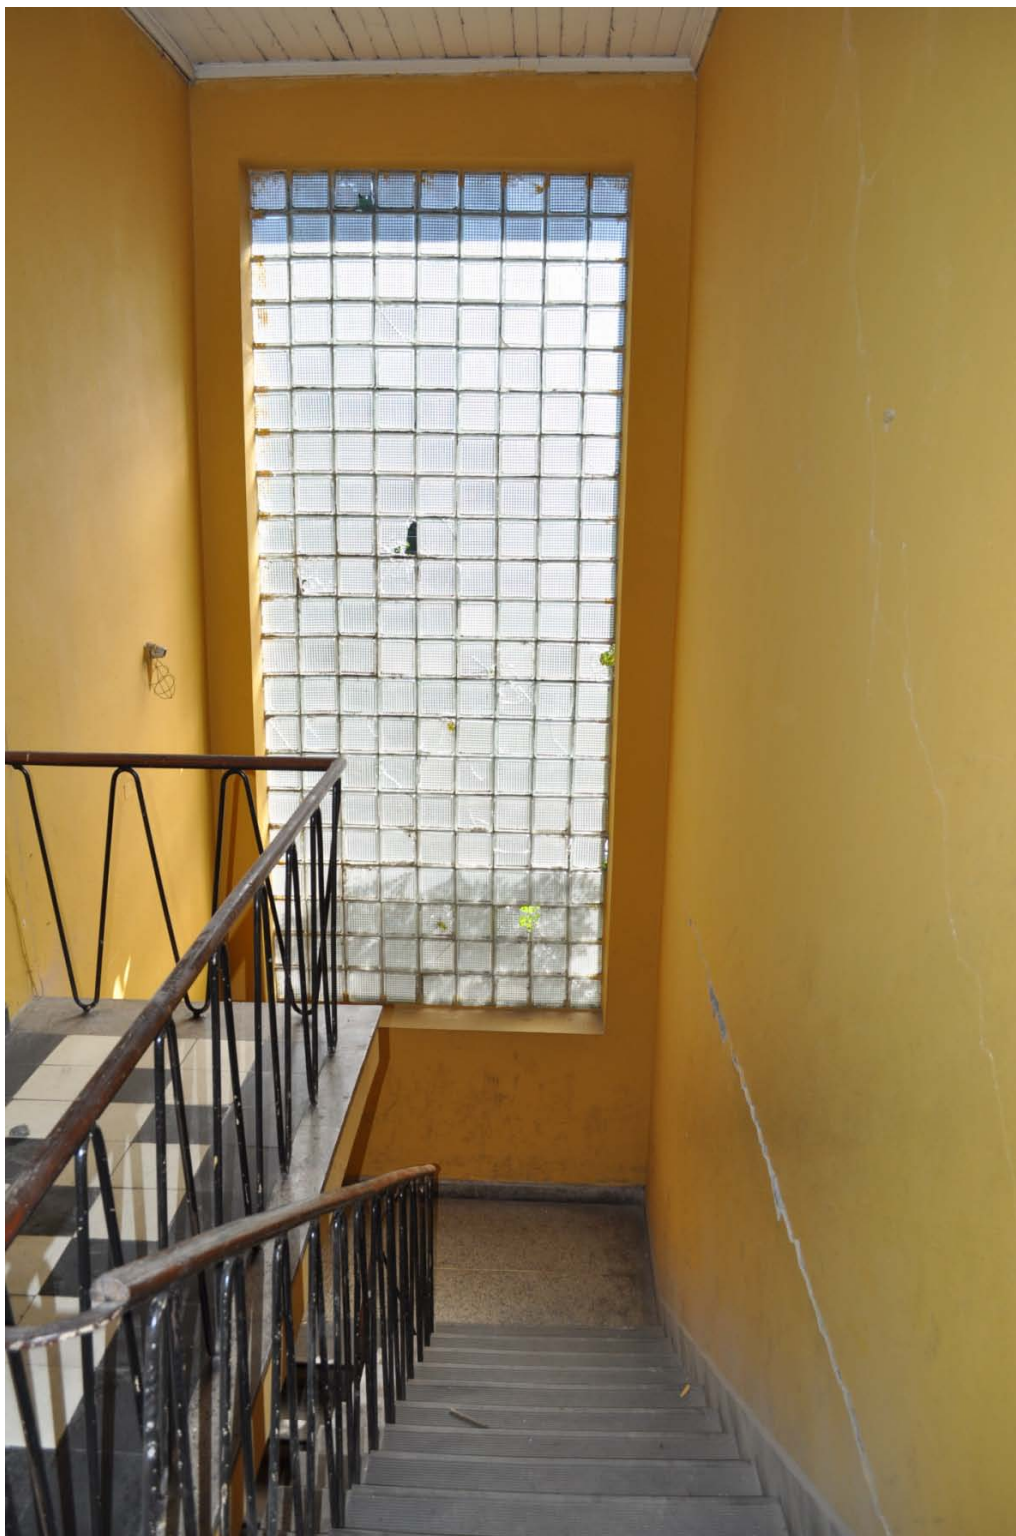
Figure 6.3.1.5-2 Damage to glass block with rigid mortar on all sides and in all joints in the 2010 Chile Earthquake (Photo courtesy of Eduardo Fierro, BFP Engineers). About 25% of the glass block units are cracked or broken but entire panel will need to be removed and replaced.

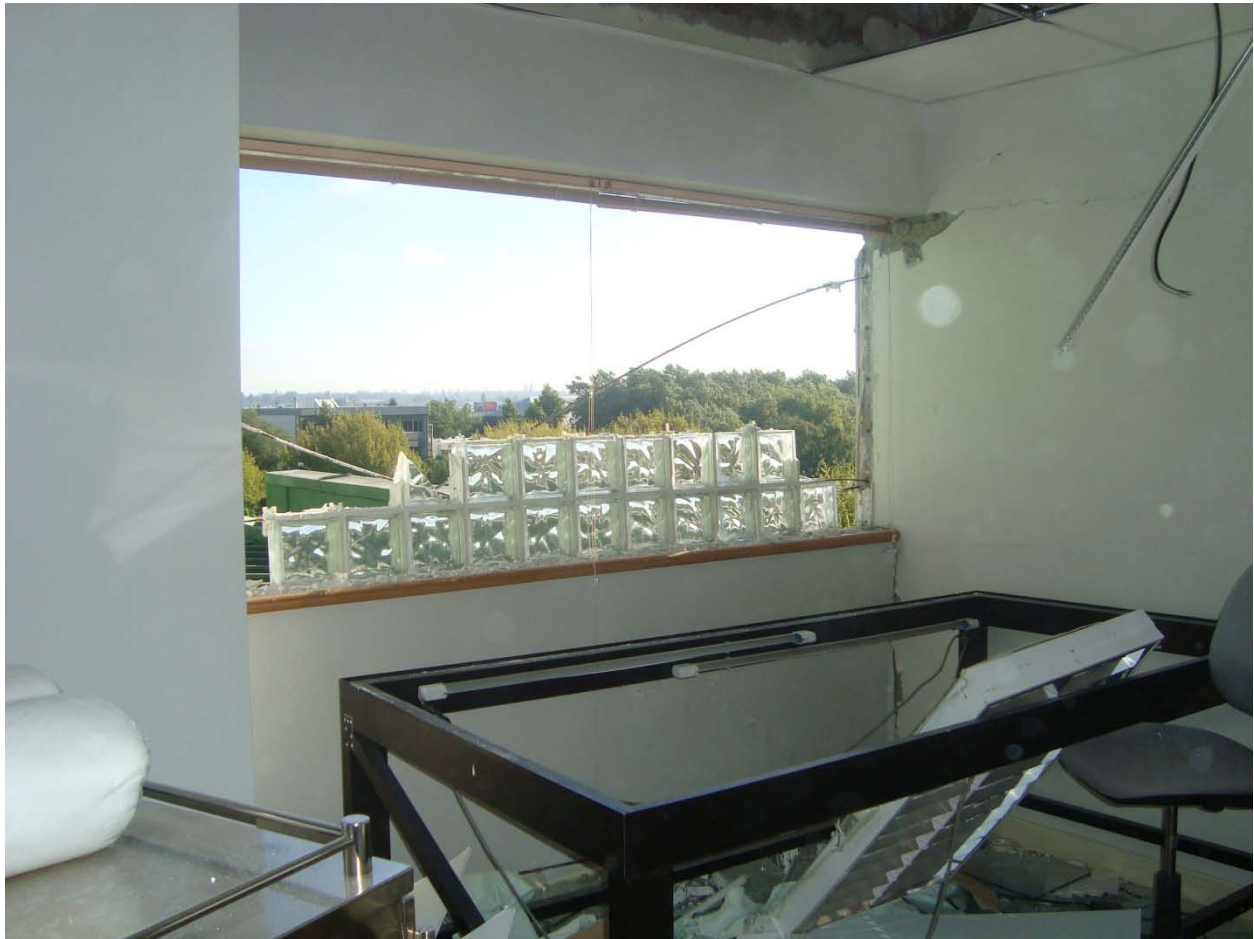
Figure 6.3.1.5-3 Damaged glass block panel from the Los Angeles Hospital in the 2010 Chile Earthquake; relatively new hospital building that had to be evacuated for repairs (Photo courtesy of Bill Holmes, Rutherford & Chekene). Blocks were installed with steel reinforcing bars in the top and bottom horizontal joints.

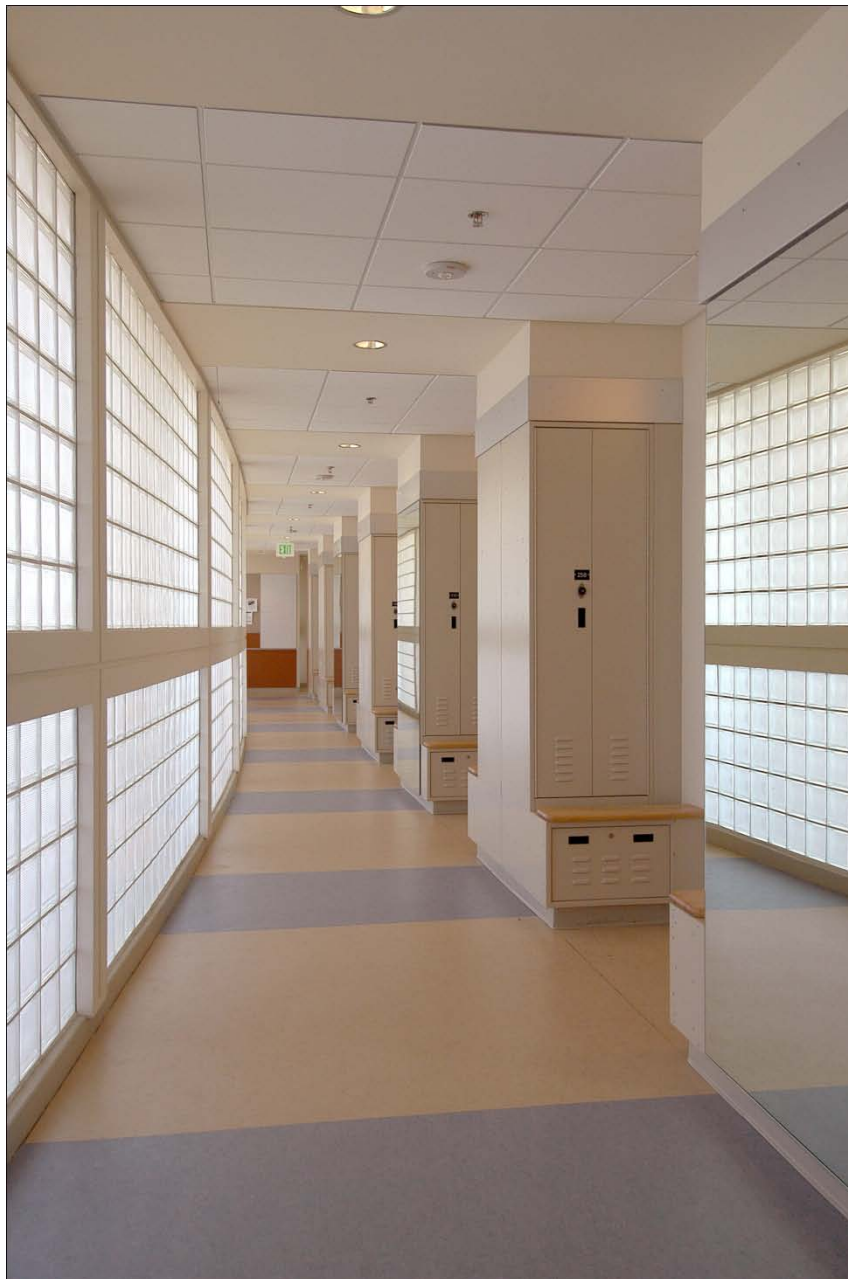
Figure 6.3.1.5-5 Glass block panels divided into numerous subpanels at the Chula Vista Police Headquarters, California (Photo courtesy of Pittsburgh Corning Corporation). In addition, the nonbearing glass block panel partition wall is isolated from seismic movement of the building structure.
